National Transportation Safety Board

Aircraft Accident Brief

Accident Number: DCA07MA003
Operator: Private Owner
Aircraft and Registration: Cirrus SR20, N929CD
Location: Manhattan, New York City
Date: October 11, 2006
Adopted On: May 1, 2007

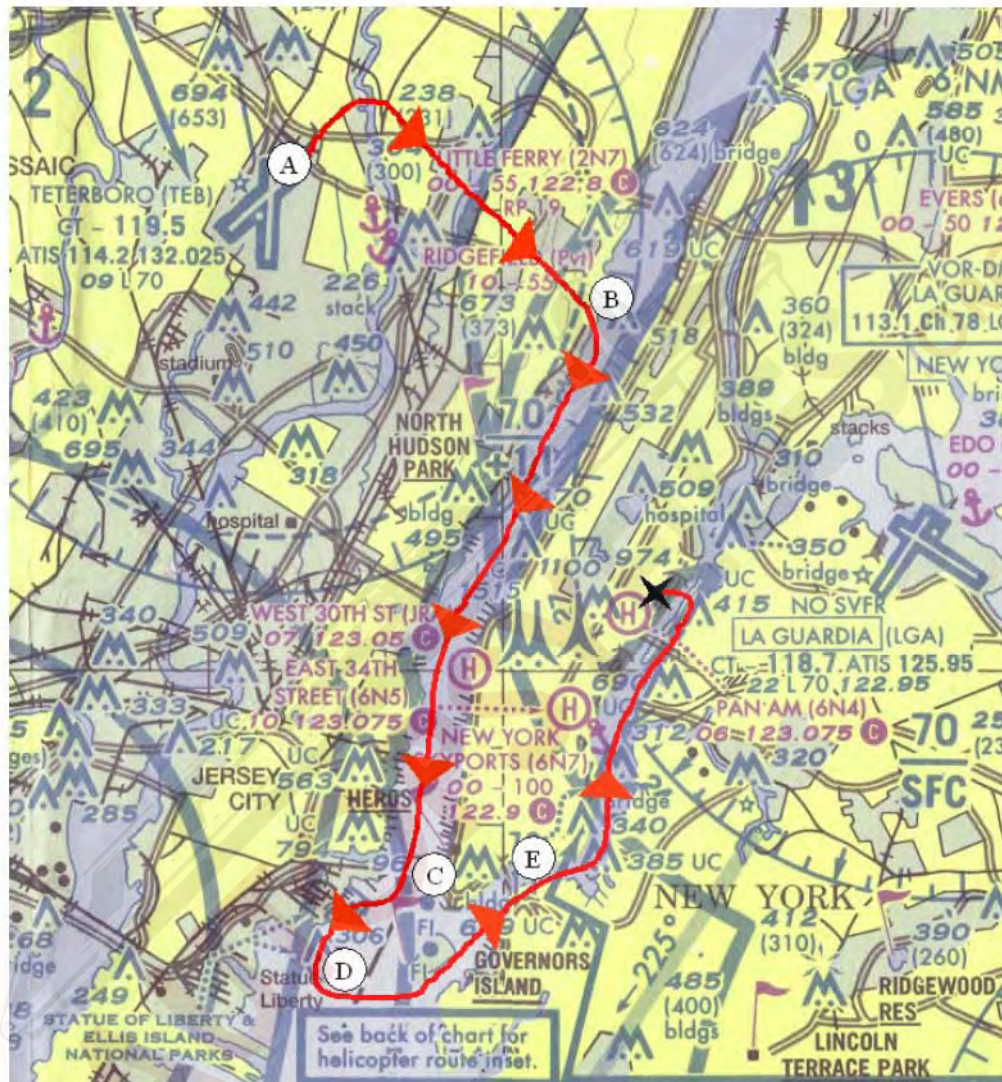
The accident airplane departed Teterboro Airport (TEB), Teterboro, New Jersey (see point A in figure 1, which shows the accident flight track), about 1429 and was cleared for a visual flight rules (VFR) departure. According to air traffic control (ATC) transcripts, the pilots acknowledged that they were to stay out of the New York class B airspace.³ After takeoff, the accident airplane turned southeast and climbed to an altitude of about 600 to 800 feet.⁴ When the flight reached the western shore of the Hudson River (see point B in figure 1), it turned to the south, remaining over the river, then descended to 500 feet.⁵ The flight continued southbound

over the Hudson River until abeam of the southern tip of Manhattan (see point C in figure 1), at which point, the flight turned southwest bound.⁶ Radar data from John F. Kennedy International Airport (JFK), Jamaica, New York; Newark International Airport (EWR), Newark, New Jersey; and Westchester County Airport (HPN), White Plains, New York, indicated that the accident airplane's altitude varied from 500 to 700 feet for the remainder of the flight.

Figure 1. Accident flight track for N929CD.

About 1436, the airplane flew around the Statue of Liberty (see point D in figure 1) then headed to the northeast, at which point, it proceeded to fly over the East River (see point E in

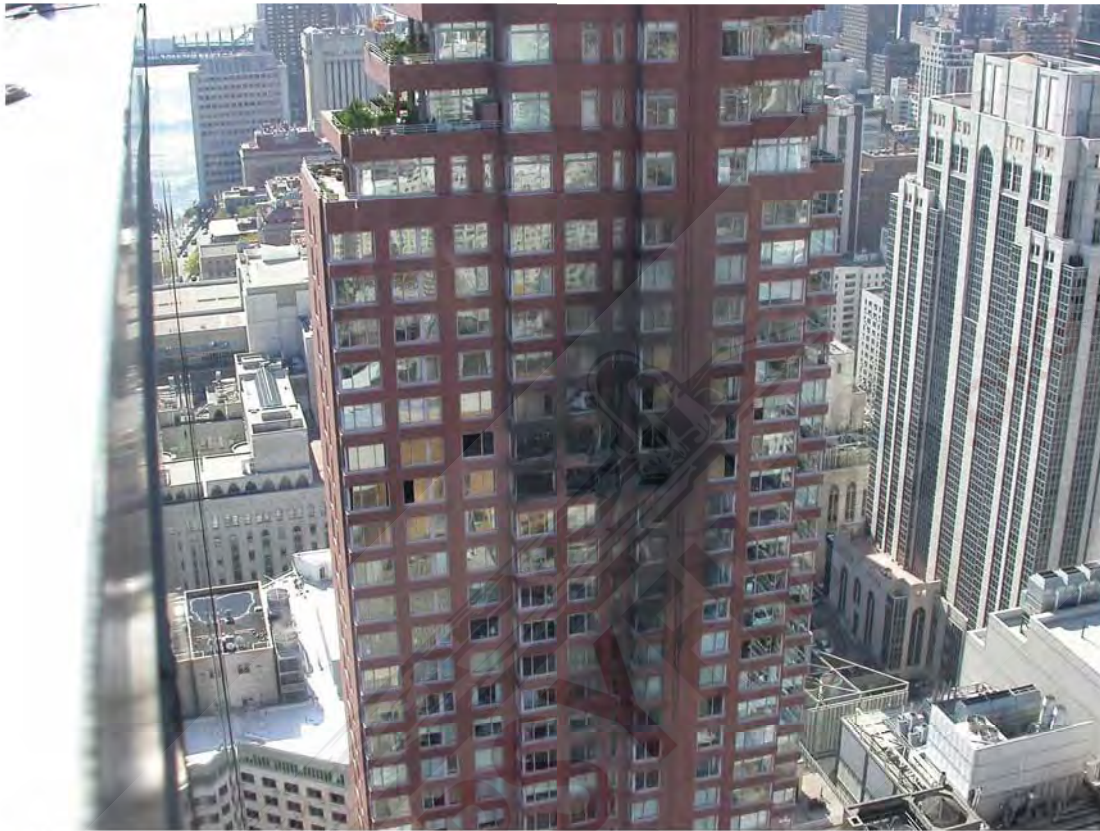
figure 1).⁷ About 1 mile north of the Queensboro Bridge, the airplane made a left turn to reverse its course. Radar contact was lost about 1442. The airplane impacted a 520-foot tall apartment building at 524 East 72nd Street, 333 feet above street level (see figure 2).

Figure 2. Photograph of apartment building that N929CD impacted.

The airplane impacted the 32nd and the 33rd floors of the north face of an apartment building located at 524 East 72nd Street. The engine, propeller, the right portion of the engine mount, and the nose landing gear strut were found in an apartment on the 32nd floor. The engine was found inverted with the propeller separated. The engine and propeller exhibited thermal damage and were coated with ash, debris, and fire-extinguishing agent.

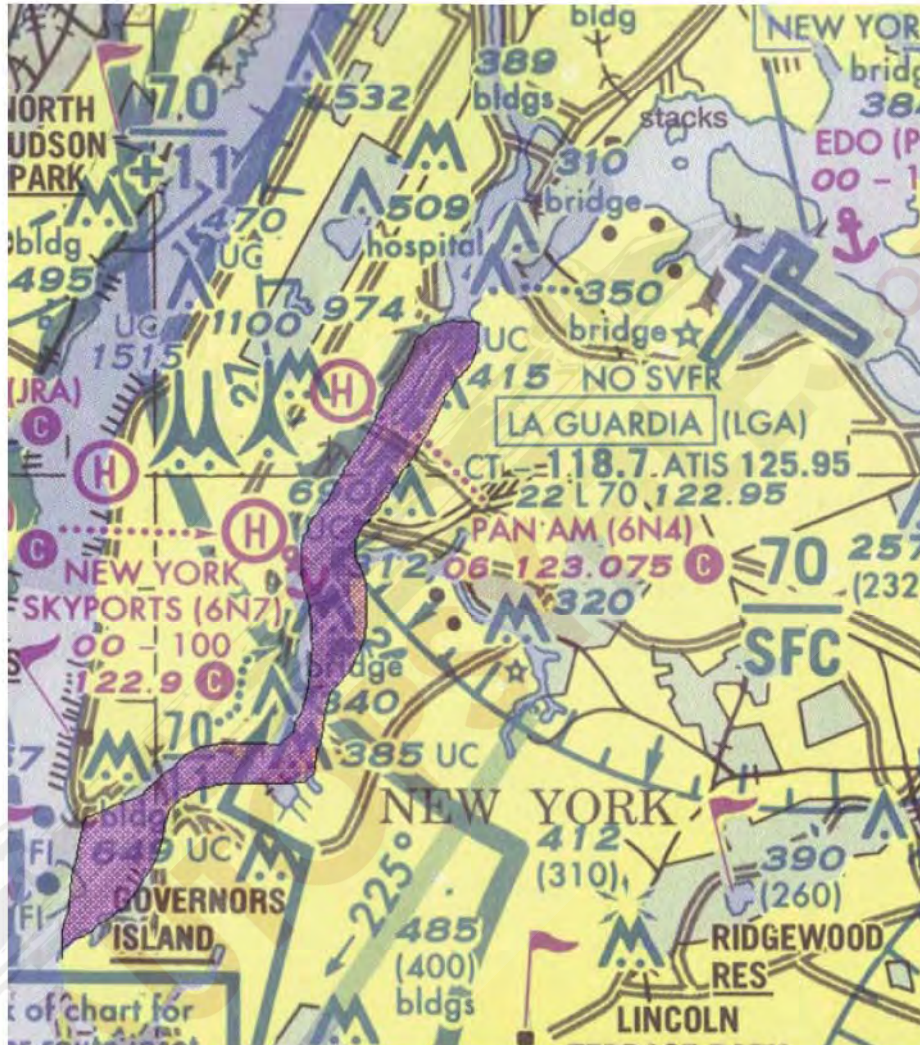
VFR operations are authorized below the class B airspace surrounding Manhattan Island in designated zones called the Hudson River and East River exclusion areas (the shaded area in figure 3 outlines the East River exclusion area, where the accident occurred). These exclusion areas were first defined in 1971. The FAA stated that the purpose of the Hudson and East River

Figure 3. Map depicting New York East River class B exclusion.

Since the accident, the FAA issued Notice to Airmen (NOTAM) 6/3495 temporarily prohibiting fixed-wing aircraft, such as the accident airplane, from operating in the East River class B exclusion area where the accident occurred unless authorized and controlled by ATC. The East River class B exclusion is in effect, but its use is limited to helicopters and seaplanes that are taking off and landing at nearby sea bases. This prohibition is intended to prevent airplane pilots from encountering a situation in which they must attempt a 180° turn or other abrupt maneuver to avoid penetrating controlled airspace and states the following:

The NOTAM is in effect until further notice; however, the charts for the area would not be changed until rulemaking action is completed. The FAA indicated in a meeting held in December 2006 between the FAA and Safety Board staff that it was planning rulemaking to make the prohibition contained in the NOTAM permanent. The Safety Board issued Safety Recommendation A-07-38 asking the FAA to make this prohibition permanent.

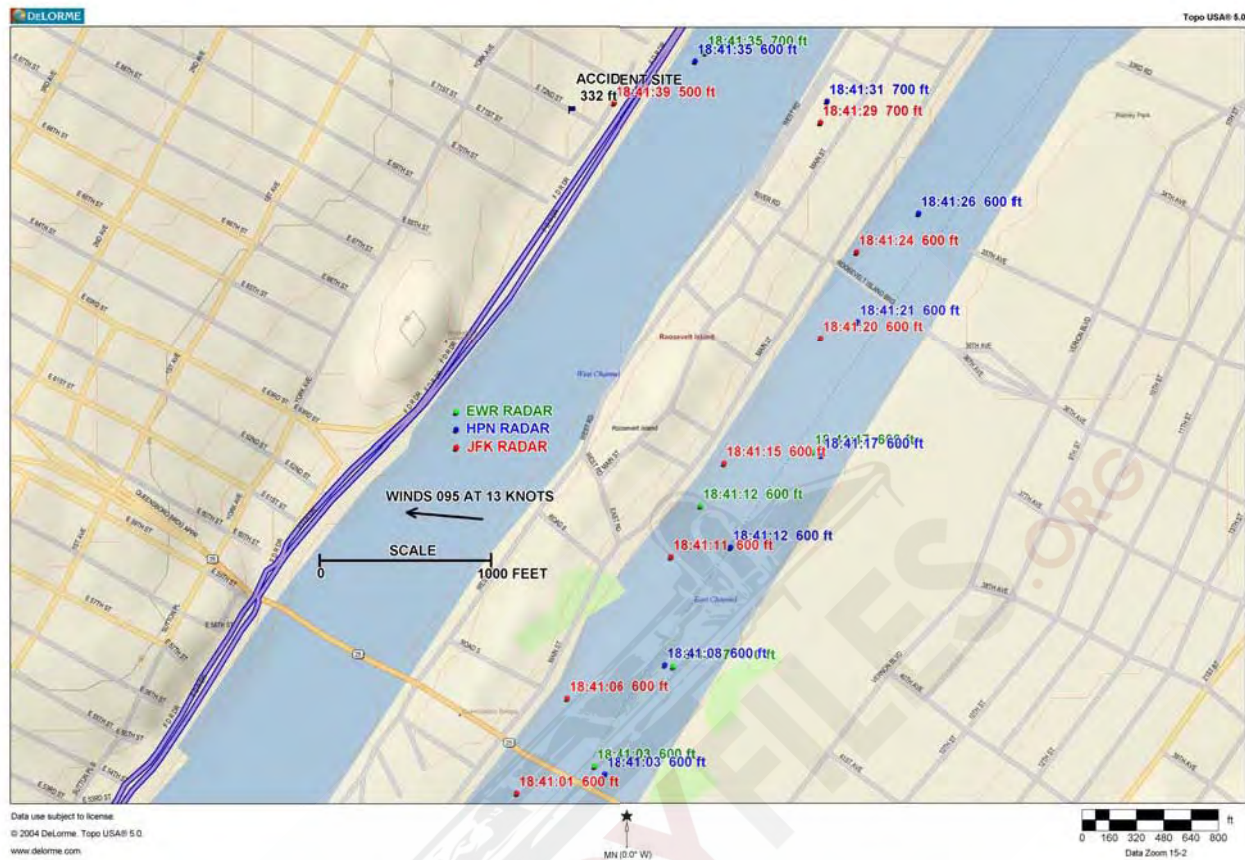
The accident airplane's constant-altitude turn performance was determined using recorded radar data, airplane performance data,¹⁰ recorded winds at 700 feet, and standard aerodynamic calculations. Radar data indicated that the airplane was flying north over the East River at about 97 knots and initiated a left turn over Roosevelt Island (see figure 4 for position location). Roosevelt Island divides the East River into west and east channels. Although the East River is about 2,100 feet wide at the turn location, the effective turn width available was reduced to about 1,400 feet because the airplane was flying near the middle of the East Channel at the start of the turn and the 13-knot easterly wind caused a measurable westward drift.¹¹

Figure 4. Radar tracks of the accident flight over the East River.

A 1,400-foot diameter constant-altitude turn at 97 knots would have required a minimum bank angle of $50^{\circ 12}$ and a load factor of 1.55 Gs. At this airspeed, the airplane could produce a load factor of 2.1 Gs at a bank angle of 61° before reaching wing aerodynamic stall. If the initial portion of the turn were less aggressive than a constant bank angle of 50° , a sufficiently greater bank angle would have been required as the turn progressed, which would have placed the airplane dangerously close to an aerodynamic stall at relatively low altitude.

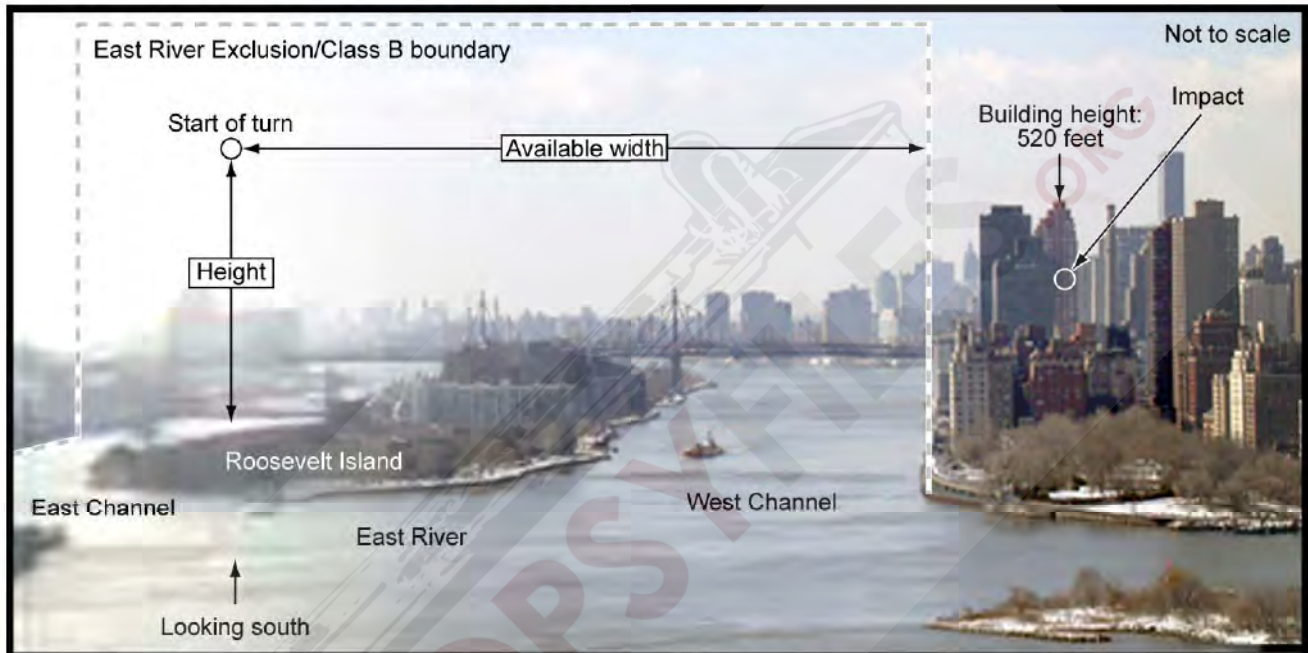
The pilots did not aggressively bank the airplane throughout the turn nor did they use the full available width of the river. Radar data indicate that the airplane was in the middle of the

East Channel at the start of the 180° turn (see figure 5) as opposed to beginning the turn from the eastern shoreline. Although it cannot be determined whether the pilots were aware of the wind's effect on the execution of the 180° turn, they should have been able to observe the difference in the ground track and heading during the flight to determine that there was a wind from the east and compensate for westward drift. Alternatively, the pilots could have dramatically improved the turning performance by transitioning to the west side of the East River, taking advantage of the full width of the river, and making a right turn into the easterly wind. By starting the turn on the west side of the river and turning into the wind, a minimum bank angle of 35° would have been needed, rather than the minimum 50° required by turning in the direction of the wind.

Figure 5. Photo illustration depicting the available width for the turn maneuver and the approximate location of N929CD at the beginning of the turn maneuver.
